Škoda Rapid Sedan 2013 → PU Side Mouldings F-46

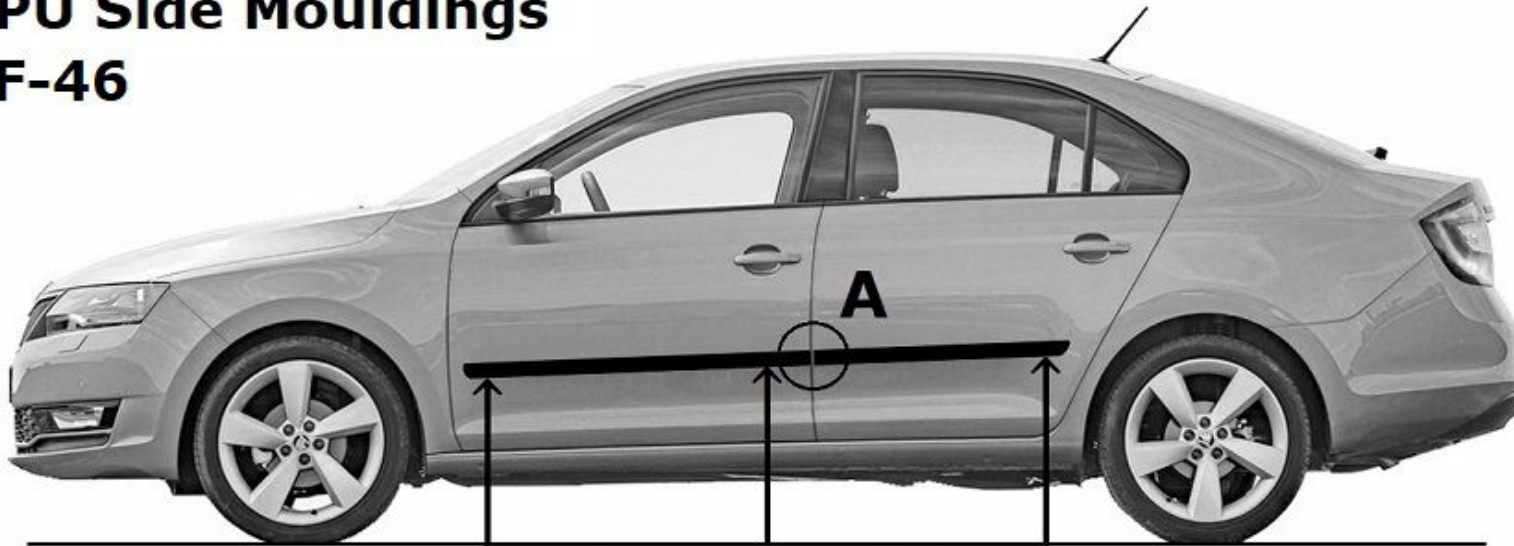
nad przetłoczeniem
over the line
über dem Strich

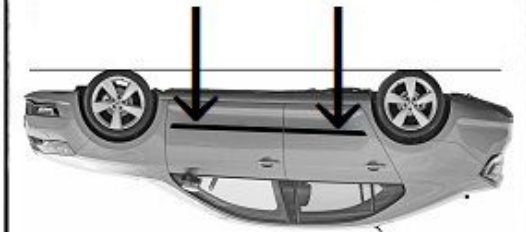
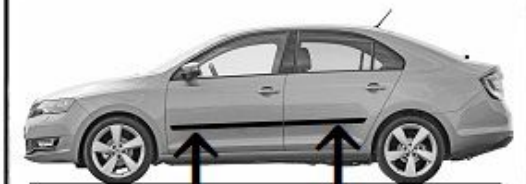
RH FRONT RH REAR

← FRONT

LH FRONT LH REAR

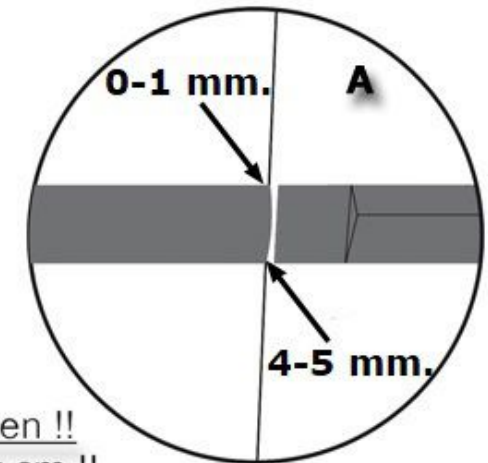
A

0-1 mm.

4-5 mm.
